Structural Deterioration and Failure of the Laminated Wooden Roof of a Covered Swimming Pool

Abstract: A swimming pool in Corrales de Buelna (Cantabria) was demolished in March 2017 due to the loss of mechanical performance of the laminated timber structure. The relevant deterioration was caused by rotting of the wood and corrosion of the metal connecting elements. The structure featured a barrel vault with five large tri-articulated arches enclosed on the sides by inclined facades formed by toral rafters and purlins. The corresponding diagnostic process involved data collection and structural assessments to verify the structure's bearing capacity and serviceability. Data collection was carried out in December 2015 and consisted of a thermal camera inspection to determine the points of moisture accumulation and sampling openings, conduct environmental and wood hygrothermal measurements, and measure cross-sectional losses and deformations of the structural elements. Verification of the load-bearing capacity was carried out using matrix calculation structure software for both the original and deteriorated structure. The diagnosis indicated that the damage was caused by leaks in the

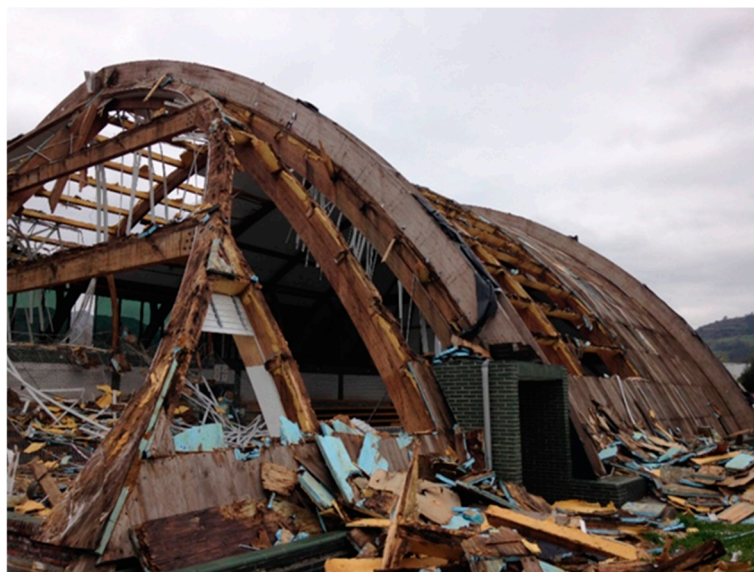
In the following years, the wooden structure began to deteriorate, and in 2016, an investigation began to investigate the causes and origin of this damage. The study concluded that the structure in its deteriorated state was not safe, which led to the subsequent closure of the facility to the public. The wooden structure's state of deterioration indicated that the structure was unrecoverable, with a recommendation to demolish it. This demolition was carried out in 2017, fourteen years after the pool's inauguration (Figure 2).

Figure 2. Building demolition.

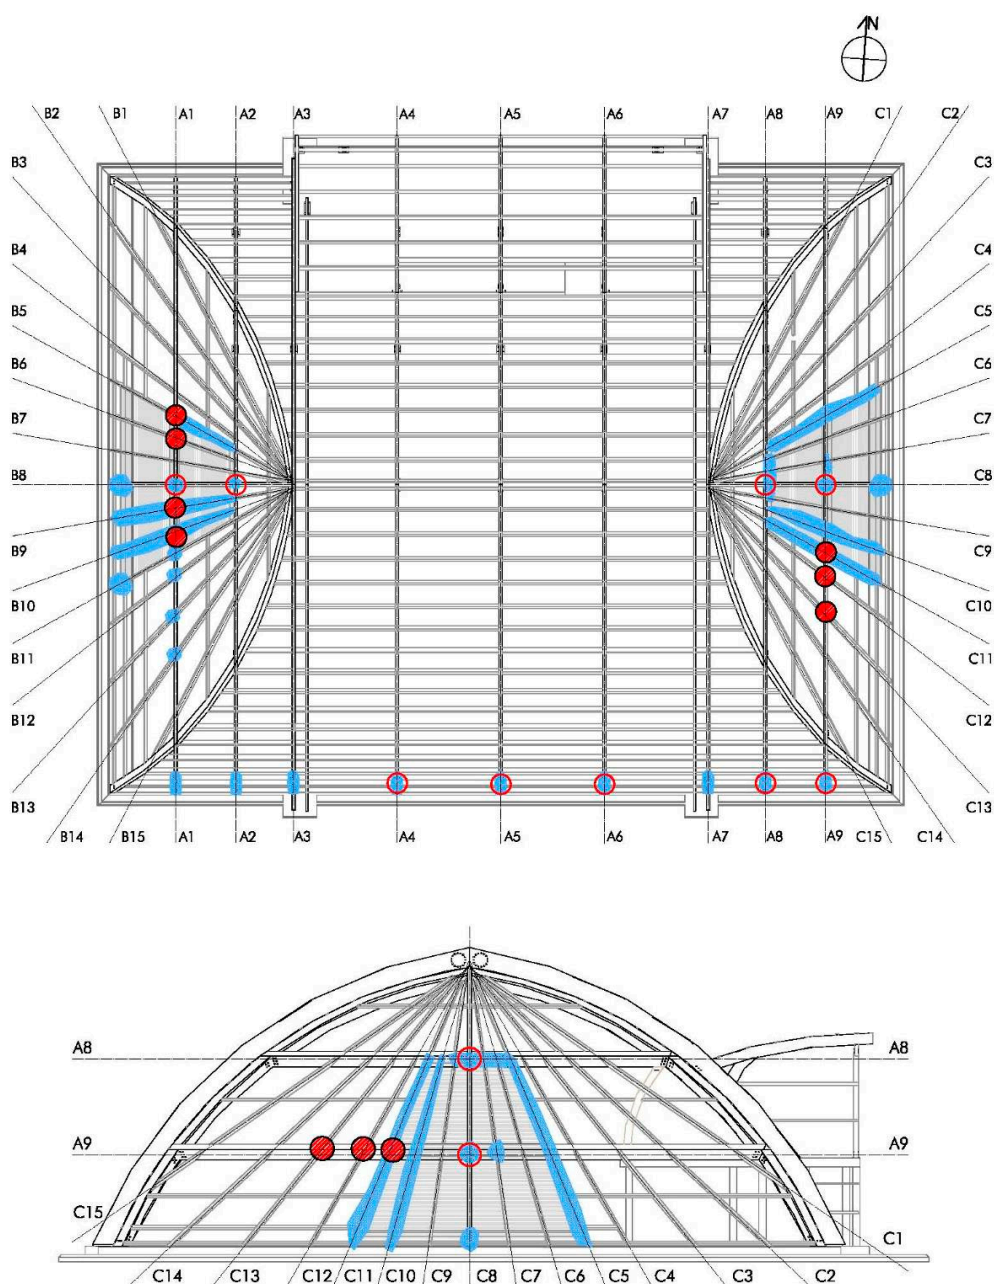
Figure 3. Plan and section with the location of damage (blue—soft rot fungi; red—breakage of connections).

The following damage to the glulam structure was observed (illustrated in Figure 3):

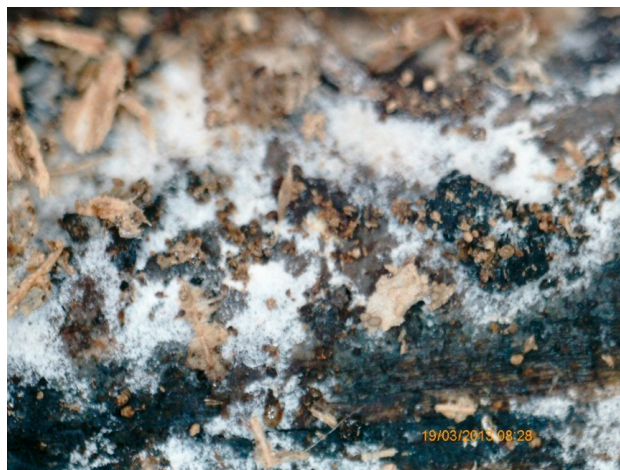
- **Soft rot fungi.** In the optical microscope images taken, it was possible to observe disintegration of the wood alongside a spongy residue with a fibrous appearance, typical of soft rot fungi that attack the cellulose and hemicellulose of the wood leaving remains of lignin under conditions of very high moisture content (Figure 6). This attack gives the wood a soft consistency. Black spots were also observed in the areas with rot. This damage was located in numerous elements, as follows: in the south foundation supports of all the arches where the sections lost due to rotting were 4.3 cm or smaller in size (Figure 7) (in the residual section, the depth of attack was estimated by observing the color and consistency of sawdust coming out of the drill hole, establishing a depth of 2 cm (Figure 8)); in all the foundation supports of uncovered façade pairs; in the upper faces of pairs B5, B9, B10, C5, C10, and C11; in the supports for the horizontal beams of arches A1 and A2; in toral rafter B8; in the horizontal beams of arches C5, C10, and C11; in toral rafter C8; in the supports of pairs B11, B12, B13, and B14 in the horizontal beam of arch A1; in the lower area of the sandwich panel between arches A06 and A07; and in the area behind the false ceiling between arches A08 and A09.

Figure 6. Microscopy of soft rot fungi.

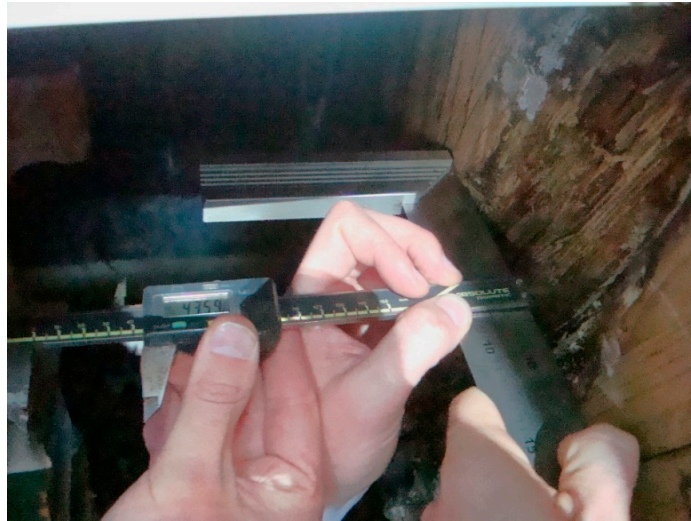
Figure 7. Measurement of sectional loss due to wood rot using a digital caliper.

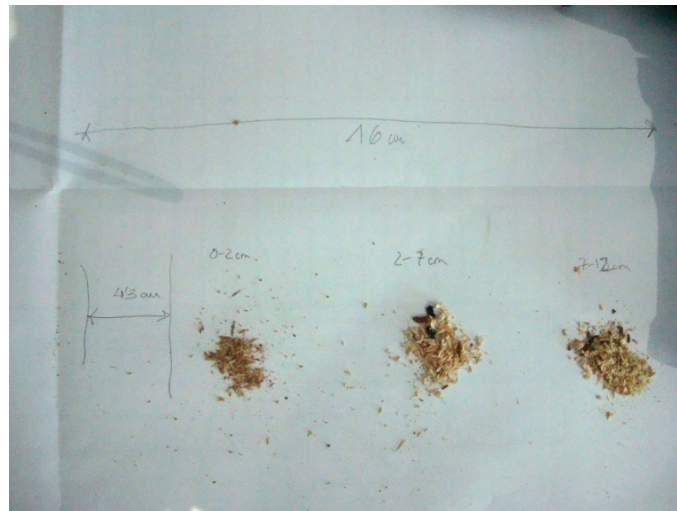
Figure 8. Sawdust extracted from a 16 cm hole drilled at the base of the arch. The depth of each extraction from the 4.3 cm sectional loss is indicated.

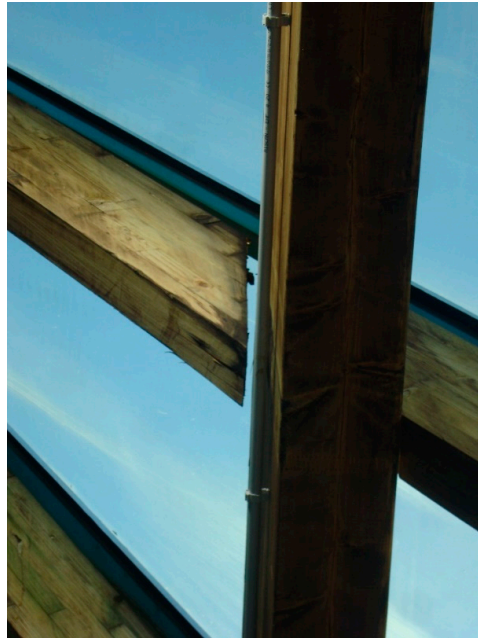
- **Breakage of connections.** The second-order elements of the structure were joined to the first-order elements via structural screws for wood (Figure 9). The screws were broken in the inclined facades—specifically at the connections of pairs B5, B6, B9, and B10 in the horizontal beam of arch A1 and at the connections of pairs C10, C11, and C12 in the horizontal beam of arch A9. It was observed that reinforcement fittings were placed in the previously broken connections of pairs B2, B3, B4, B5, and B6 on the horizontal beam of arch A1.

Figure 9. Breakage of fixings between the pair and beam.

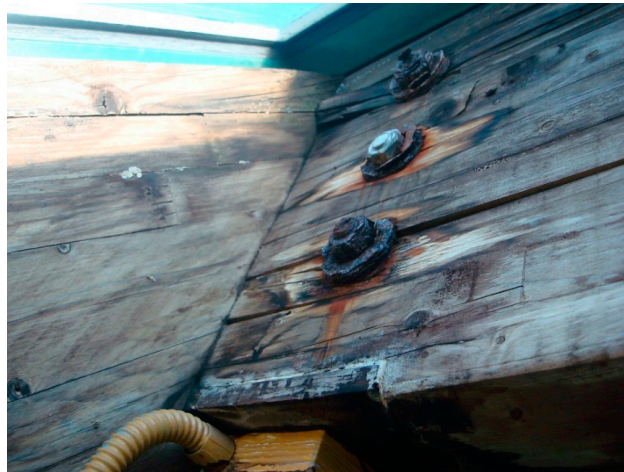
- **Corrosion of metal connections.** Corrosion was observed in the metal elements used in the supports of the toral rafter, specifically in the connections of the horizontal beams of arches A1 and A2, in toral rafter B8, and in the connections of the horizontal beams of arches A8 and A9 in toral rafter C8 (Figure 10). Corrosion was also found in the supports of all the arches. To prevent this type of corrosion, it is recommended to employ screws and washers made from the same metal, use stainless-steel fasteners, or apply a waterproof plastic film coating such as epoxy resin [25].

Figure 10. Corrosion of nuts, washers, and threaded rods in beam connections.

Corrosion of the steel connecting elements in wood is caused by high ambient humidity. The corrosion of steel requires water to act as an electrolyte, so humid environments make it possible for corrosion to occur. The corrosion process of steel is also aggravated by wood moisture content since it accelerates in acidic environments. Spruce wood has a pH of 5 [6] due to the presence of free acids. Acetic acid is exuded during wood drying processes. Under normal conditions, wood is placed dry, so the acetic acid never comes in contact with steel bolts and plates. In this case, however, the wood was continuously wetted and dried. Consequently, acetic acid was continuously produced and came into contact with the steel, lowering its pH and accelerating the corrosion process. This factor explains the high degree of deterioration on the steel connecting elements of the timber structure.

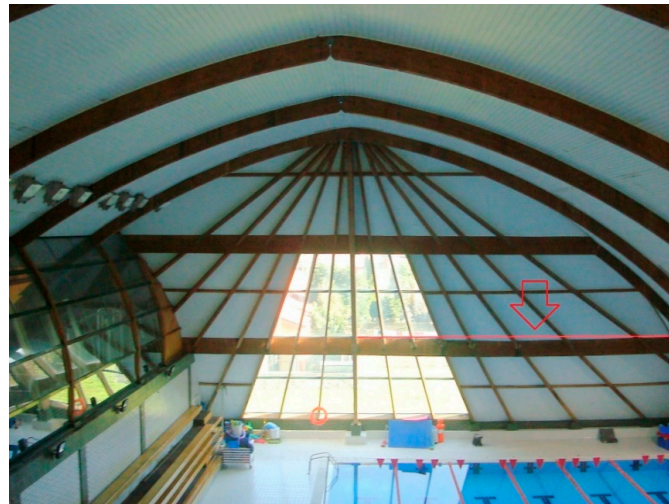
- **Excessive deformations.** On the day of the visit, the weather conditions were ideal, with no wind or snow, which could have led to extreme serviceability of the structure. Very high deflection was observed in the horizontal beams of the gables in arches A1 and A9. The deflection at the mid-point was 10 cm for an 11 m span element, corresponding to a span/110 deflection (Figure 11).

Figure 11. Deflection of a horizontal beam in the inclined façade.

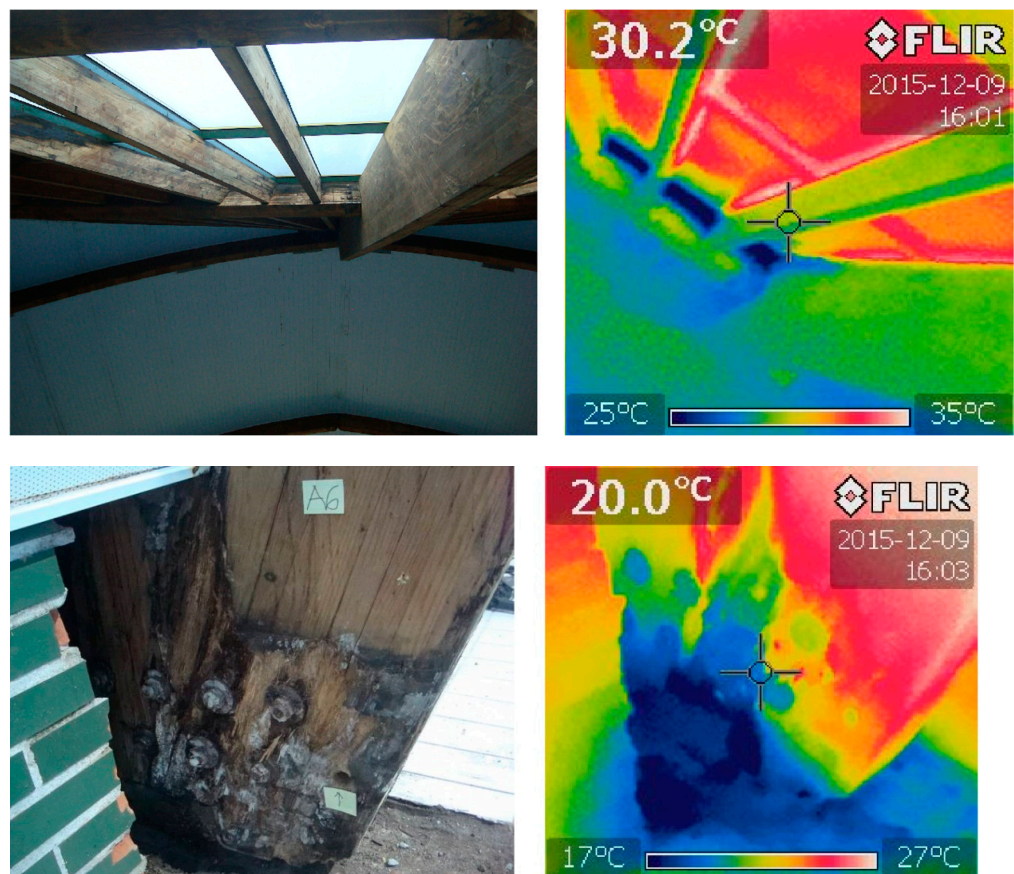
It was also found that the moisture content of rotten areas on the supports of arches ranged from 23.7% to 68%, with lower sections being the wettest. In the upper areas of arches featuring no rotting, the moisture content was 15%. In the remaining areas without detectable rot, the moisture content ranged from 54% to 87.6%.

Figure 12. Thermal camera images of the toral rafter's foundation and A6 arch support. An RGB image is presented on the right.

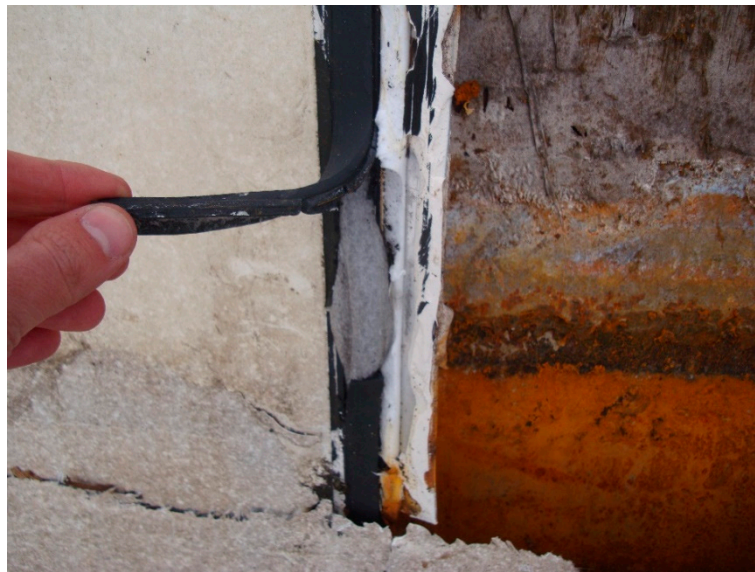
Vertical joints between panels had different omega joint profiles but with the wings facing upwards. The omega profile was filled with foamed polypropylene and sealed with silicone (Figure 15). The seals showed damage and vegetation growth.

Figure 15. Aluminum omega profiles placed in the vertical joint between the composite panels. The section is filled with a foamed polypropylene as the bottom of the joint and sealed with silicone.

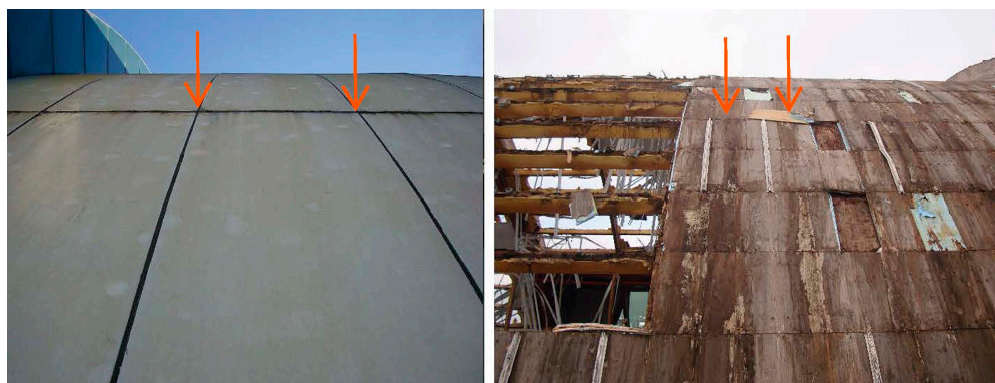
Seepage occurred through the screws fixing the aluminum profiles to the wooden sandwich panel (Figure 16). The water first penetrated through the silicone seals between the aluminum composite panels and then ran along the omega profiles acting as a channel, eventually seeping to lower layers through the screws fixing the profile to the wood sandwich panel (Figures 17 and 18).

Figure 16. Left of the image: composite roof panels before demolition. Right of the image: the wooden sandwich panel during the demolition process. Red arrows indicate areas of water seepage through the composite roof panels.

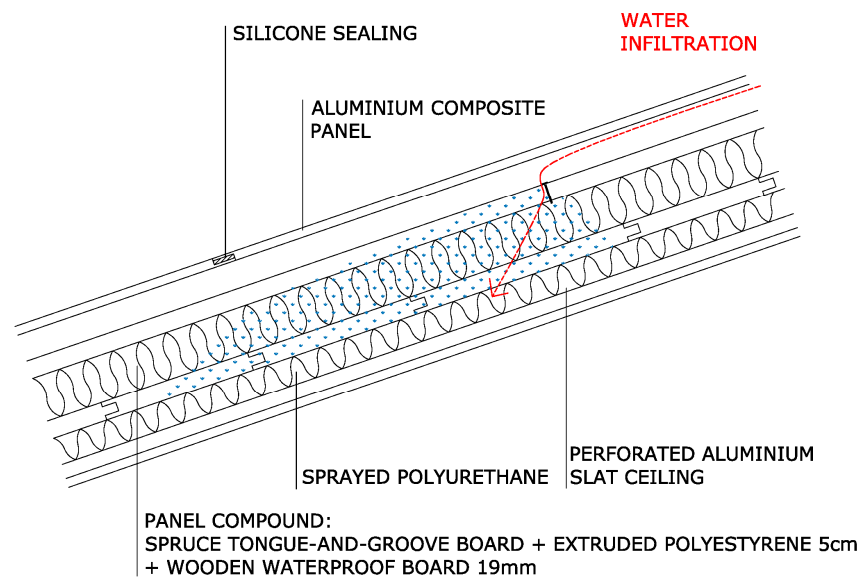
Figure 17. Construction cross-section of the roof indicating its construction elements and water seepage points.

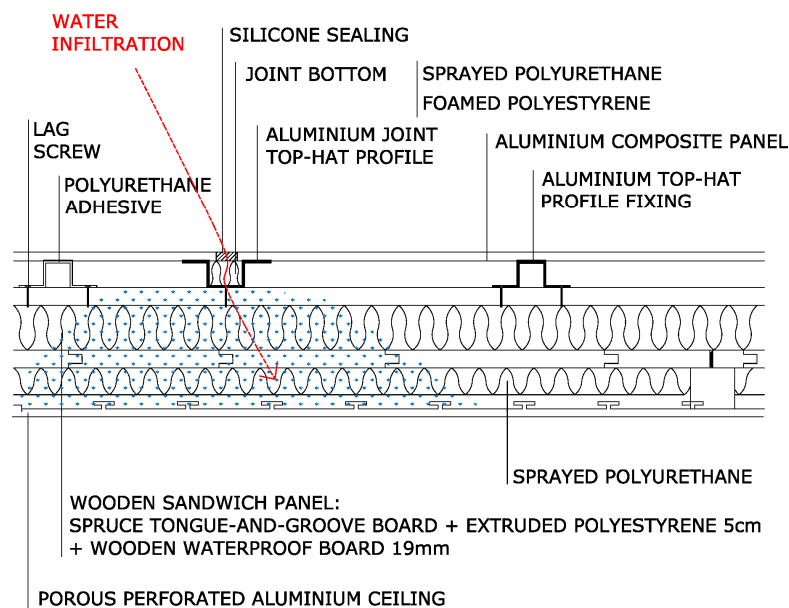
Figure 18. Longitudinal constructive section of the roof with indications indicating its constructive elements and water seepage points.
