Detailed studies and stabilization methods of volcanic rocky slopes in coastal areas, Canary Islands, Spain

Chapter · May 2010

A. Lomoschitz & A. Cilleros

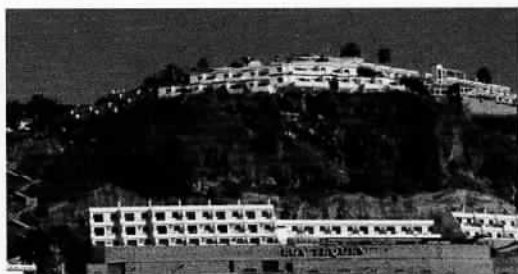
Figure 2. General view of Los Teques apartments and rocky slope in Southern Gran Canaria Island.

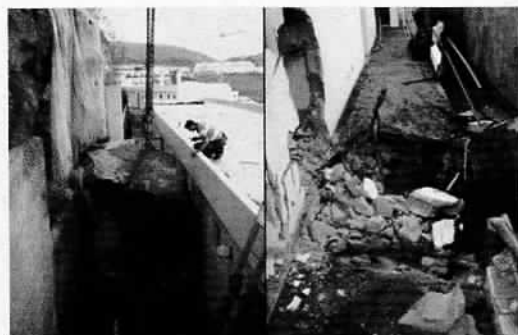
In December 2005 a 11.6 metric ton rock block fell down on the back corridor of the apartments and the structure of the building was damaged. For some days, other smaller rock falls occurred. Afterwards, by means of a detailed geological study of the whole slope, 105 m long and 30 m high, 9 zones of medium to high risk were found out. In the study there were considered the strength and weathering of the rocks, potential rock fall mechanisms and trajectories, and the superficial and underground waters influence.

The volcanic agglomerate outcrops at the base of the slope, just behind the apartments, with a thickness of 10–15 m. Its high slope angle (70–80°) and weathering had caused the undermining of the upper lava flow layers, which are 15–20 m thick. These layers had a number of unstable rock blocks with varied (wedge-, columnar-, cubic-) forms (Fig. 3).

Figure 3. Removal of the 11.6 tons rock block that fell down at the back of the building. Damages caused by this rock fall.

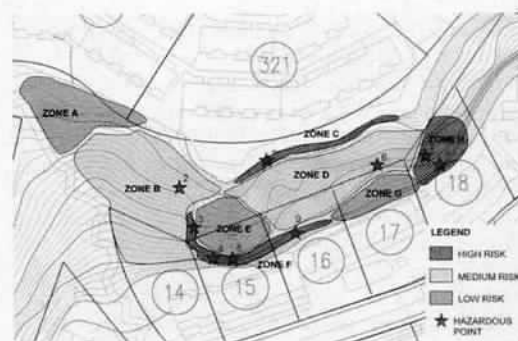
When the unstable zones had been identified, one by one, a rock fall hazard map was done, considering three categories of risk: low, medium and high. Construction solutions were mainly focused on the stabilization of medium and high risk zones (Fig. 4).

Figure 4. Risk map of Los Teques slope. Stabilization methods were focus on medium to high risk zones.

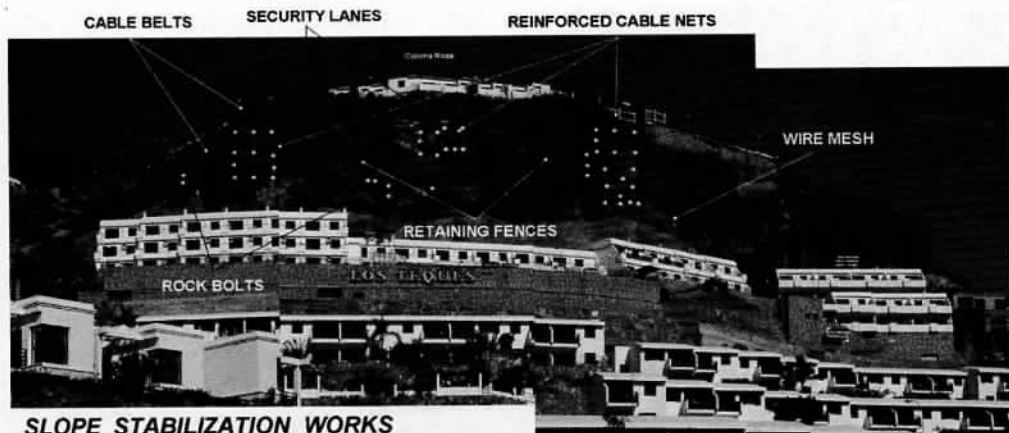
Figure 5. Stabilization methods used on Los Teques slope.

- Removal of loose stones and debris (450 m²).
- Concrete buttress to support rock above cavities (18 m²).
- 20 drain holes to reduce water pressure within slope.
- Wire mesh hung on vertical face of slope (260 m²).
- Reinforced cable net and rock bolts on unstable rock blocks (180 m²).
- Small fences (1 m high) to retain canalized debris flows (2 fences of 15 m).
- Cable belts around semi-unstable rock columns (3 zones).
- Tensioned rock bolts in rock blocks (10 units).

The final cost of the stabilization works was €45,000, less than a half of the budget cost of other more extensive and general solutions.

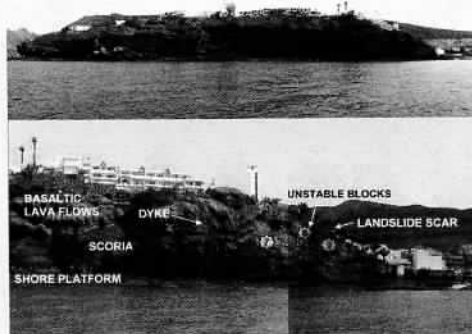
In 2006 a project for a coast footpath, 450 m long, was done. It would connect Morro Jable harbour and El Matorral beach, located in a main tourist area at Southern Fuerteventura Island. The path had to be designed on a narrow strip of land, along a rocky cliff 30 m high, with a lot of caverns, landslide and rock-fall zones and very heterogeneous volcanic formations (Fig. 6).

Figure 6. General view of Morro Jable Cliff in Fuerteventura Island. Differentiation of geological materials on the slope.

- 2 zones affected by large landslides: the first is 60 m long and 20 m high and has had big rock topple and fall movements, and the second is 40 m long and 18 m high and has produced a huge debris flow deposit on the shore platform.
- 7 potentially unstable zones at different points of the cliff wall.
- 9 zones with caverns and caves at the base of the cliff.
- 3 zones on the cliff with a high degree of erodibility.

Every zone has been studied individually, having searched a building solution for each one. For instance: concrete buttresses and stone walls to support rock above caverns and caves; rock removal at some places; concrete injection inside open joints; tensioned rock bolts; reinforced cable net and bolts on unstable rock wedges and columns, etc.
