UNIVERSIDAD DE LAS PALMAS DE GRAN CANARIA

DOCTORAL THESIS
**INDICATORS SYSTEM FOR BUILT HERITAGE
MANAGEMENT
PROPOSAL AND CASE STUDIES**

AUTHOR
Carmela Cionfrini

Las Palmas de Gran Canaria, October 2021

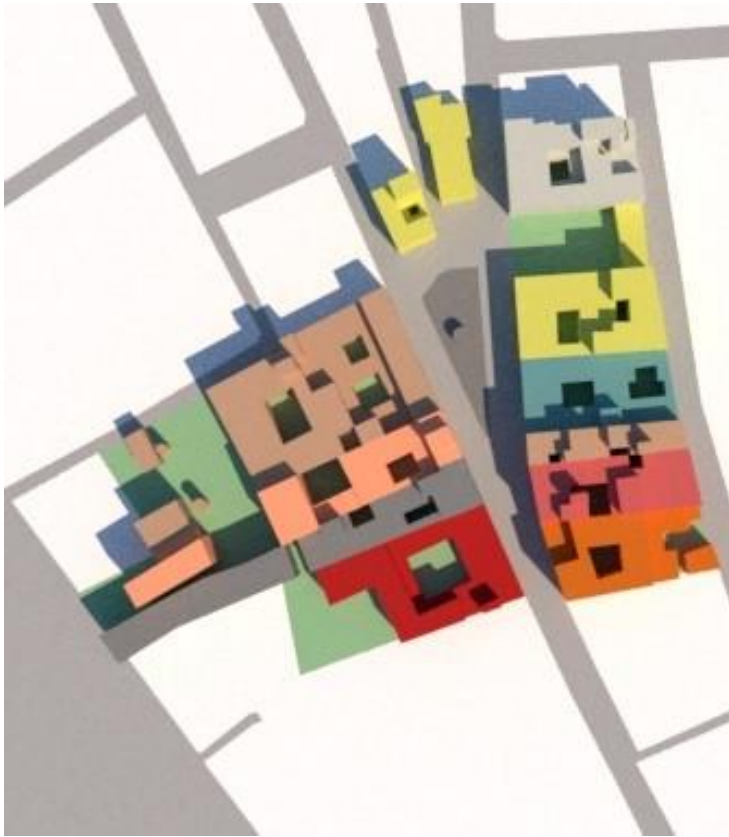
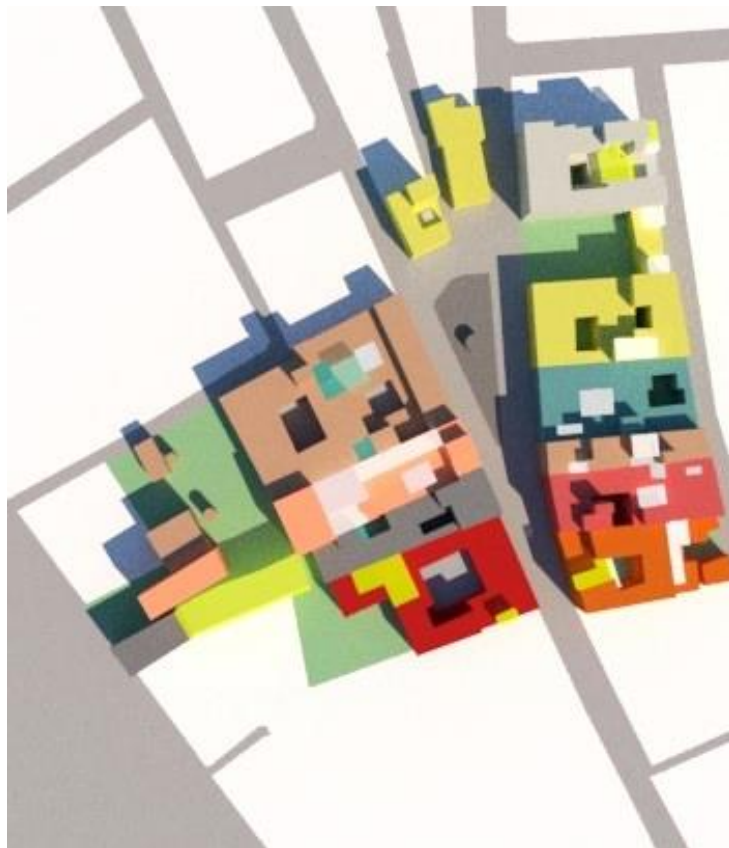
2.25 Volumetries of the set

According to Cadastre / according to direct observation and aerial photos
