Article

Integrated Application of Innovative Technologies for Oil Spill Remediation in Gran Tarajal Harbor: A Scientific Approach

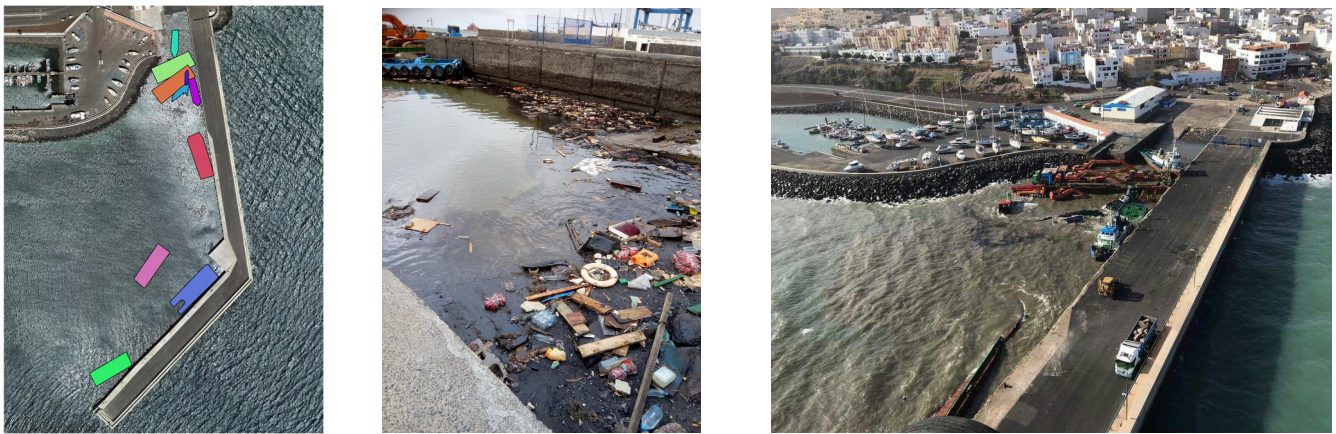
As illustrated in Figure 3, the vessels broke free from their moorings and collided with one another, gradually moving toward the base of the funnel-shaped harbor where a small black sand beach is located.

Figure 3. Final situation of wrecks (**left**), where only the blue pontoon has not sunken. Harbour interior beach (**center**). Scenario in the end of the funnel where the color of water evidence the mixture between oil, water and suspended solids (**right**).

Figure 3 center illustrates the condition of the beach adjacent to the ramp, revealing not only the presence of oil but also a substantial accumulation of solid waste and seaweed debris dislodged by the storm.

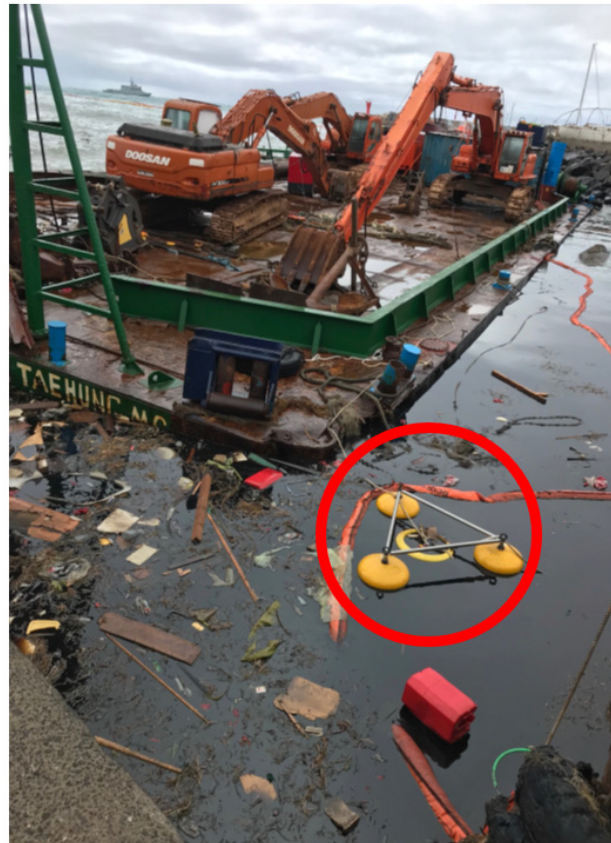
Figure 4. Standard Skimmer working (red circle).

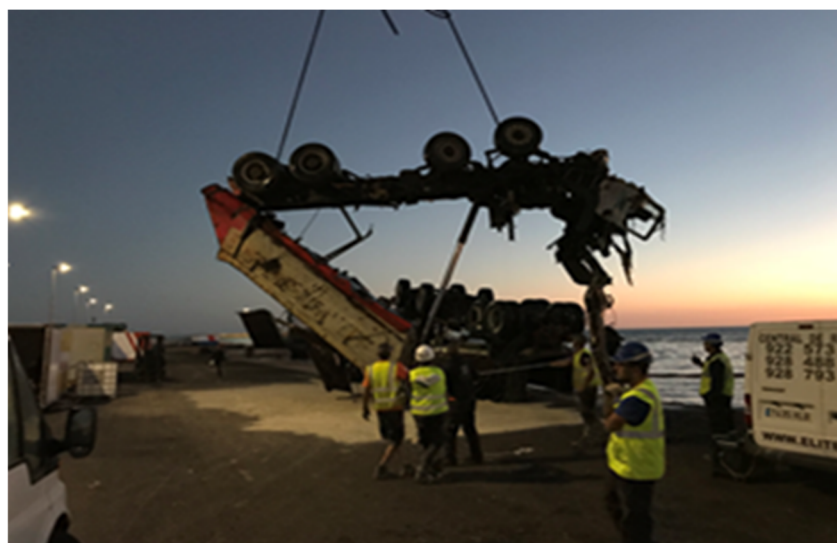
Furthermore, the cut segments of the vessels and heavy machinery (See Figure 7) contained residual hydrocarbons, posing a risk of spillage upon deposition in the port. These hydrocarbons, when mixed with water, could contaminate again the water, soil the port floor, and impede operations, endangering workers. This challenge was addressed with the introduction of another innovation in oil spill response: absorbent granules.

Figure 7. Recovery of one of the trucks.

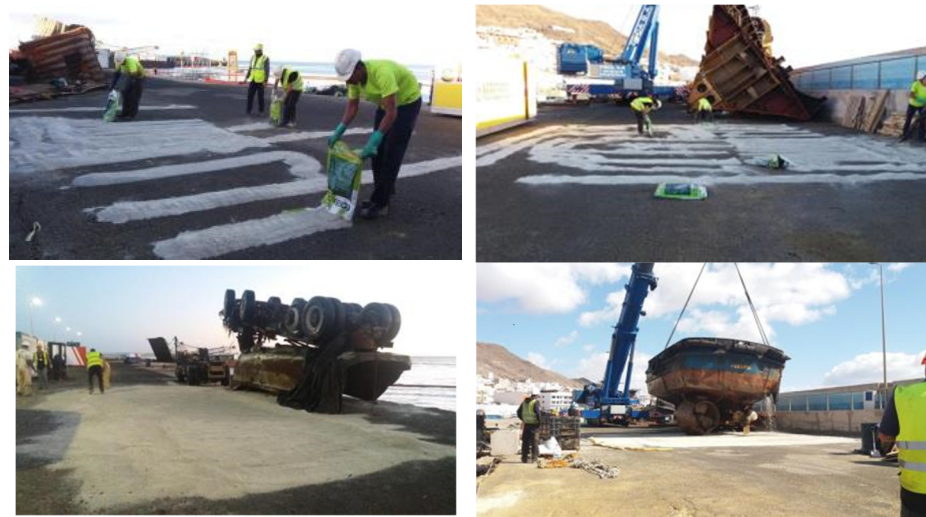
Figure 8 illustrates the sequence for preparing a granulate bed to prevent soil and water contamination in the event of an oil leak from a ship's cut part.

Figure 8. Sequence for the preparation of a bed of oleophilic and highly water-repellent absorbent granulates to protect the port soil and prevent water contamination.

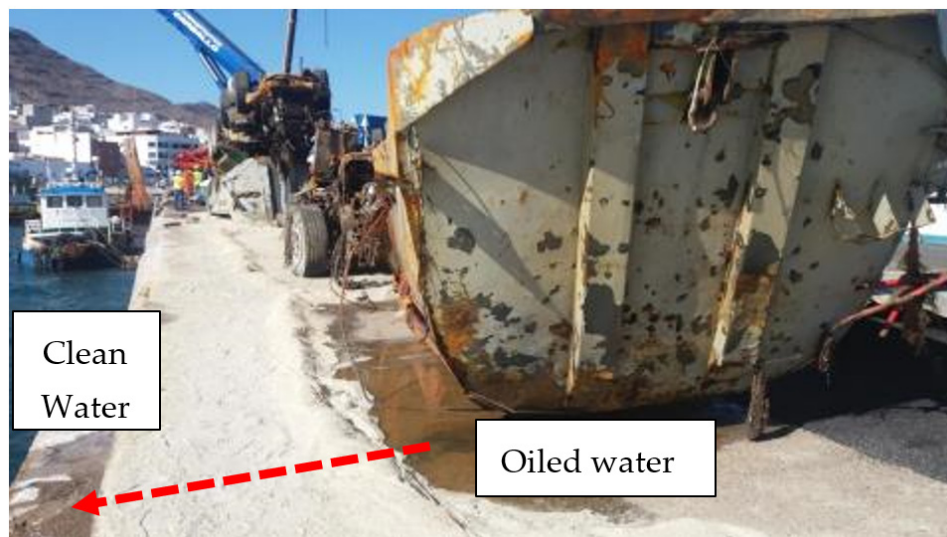
Figure 10. Filtering process for oiled water before reaching the water harbor again.

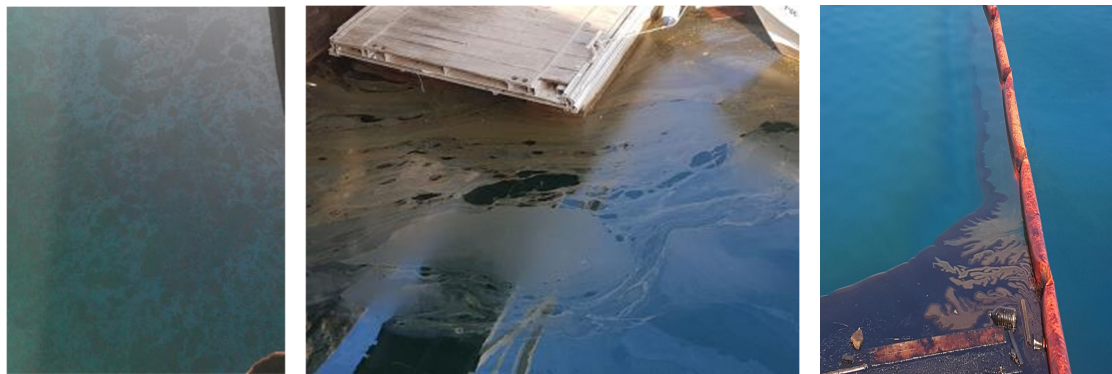
The effect of the inoculum became visibly noticeable within 20 min, as the surface of the oil began to crack (Figure 14, left), indicating the start of the degradation process. The oil underwent physical changes, such as reduced viscosity and surface tension, until it degraded into an orange layer that either accumulated in corners due to wind action or dissolved with minimal wind activity due to its lack of consistency.

Figure 14. Left photo shows the hydrocarbon layer 20 min after applying the bacterial inoculum. Center at the end of the day this layer of dead bacteria accumulates and is ingested by the fish or dissolved in the water. The right photo shows a fractal growth of bacteria in a mixture of fuel oil, diesel and oils of all types.

The effect of the inoculum was visibly noticeable in less than 20 min when the surface of the oil began to crack (Figure 14, left), indicating the degradation process as the oil changed its physical properties, particularly viscosity and surface tension. The oil degraded until it formed an orange layer that accumulated in corners due to wind action, or it dissolved with minimal wind activity due to its lack of consistency.

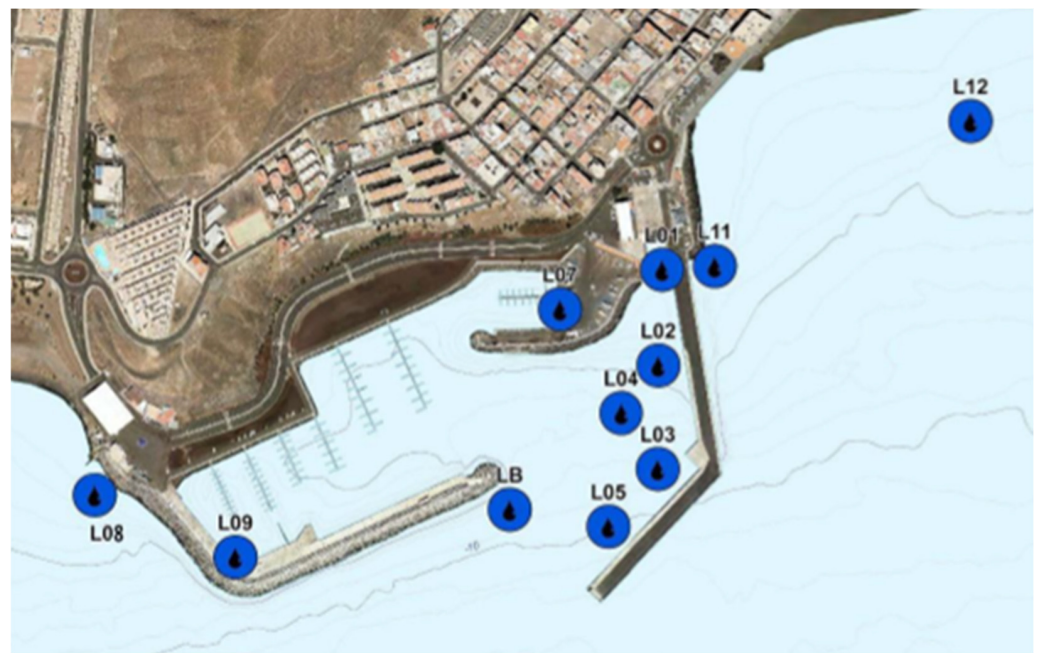
Following the Spanish Government Recommendations Program, (ROM 0.5 Program), surface water sampling was conducted from a boat. At all stations, a single sample was collected at the surface of the water column (approximately 25 cm from the surface), except for the station located at the mouth of the harbor (station LB), where three additional samples were taken at depths of 3 m, 5 m, and bottom using a Niskin oceanographic bottle. This sampling in different depths to confirm the non-stratification process of the water at the entrance of harbor. Figure 15 illustrates a map of the port with the water sampling points.

Figure 15. Map of sampling points for water samples taken.

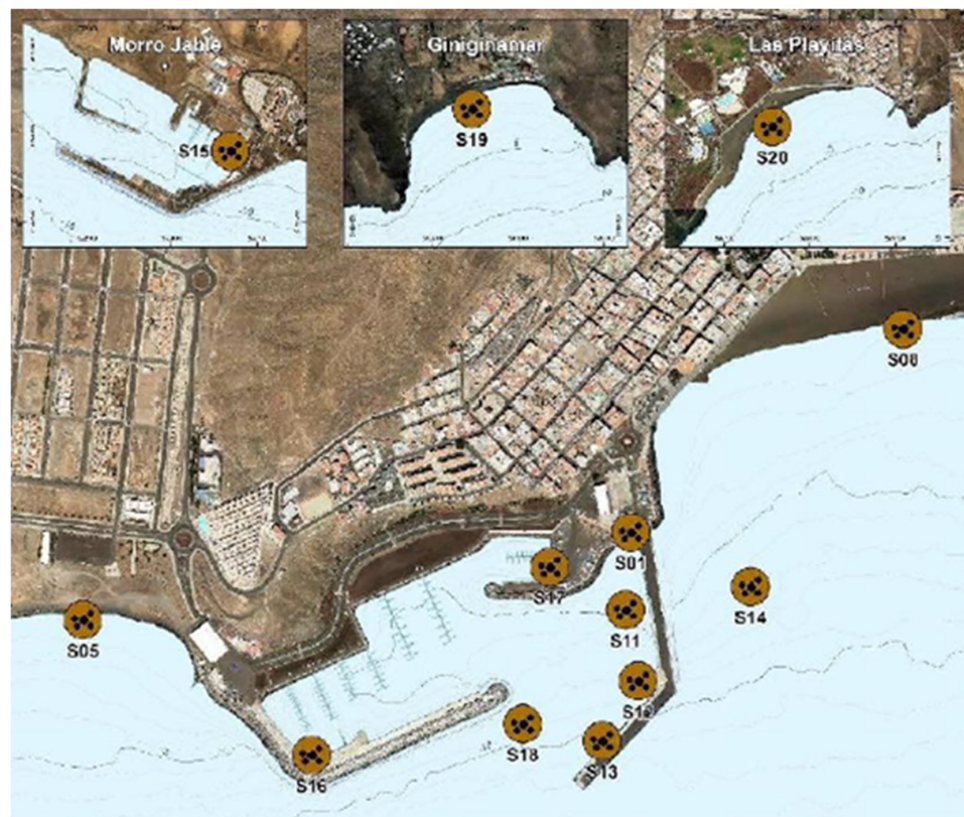
Figure 16. Map of sampling points for sediment samples taken.

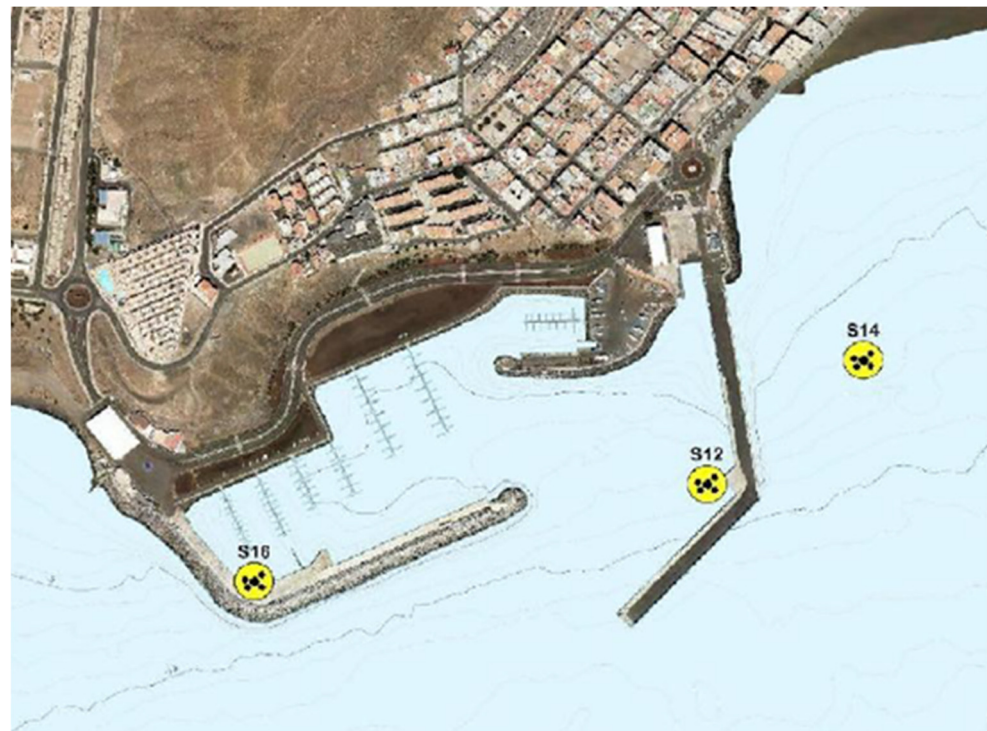
For toxicity bioassays, three sampling points were selected: two within the port and one outside, as depicted in Figure 17.

Figure 17. Map of the sampling points of the sediment samples for the ecotoxicity analysis.

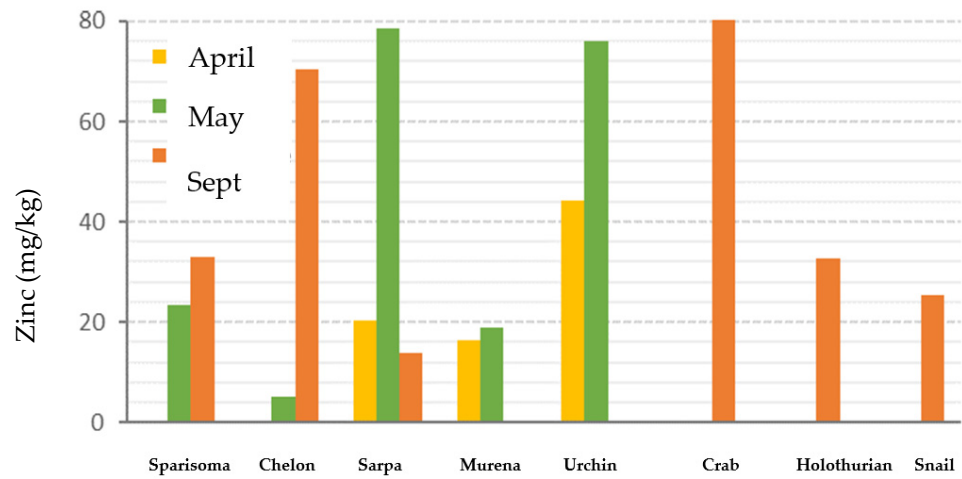
Figure 41. Zinc concentration in tissues of organisms captured in the April, May and September 2018 campaigns.

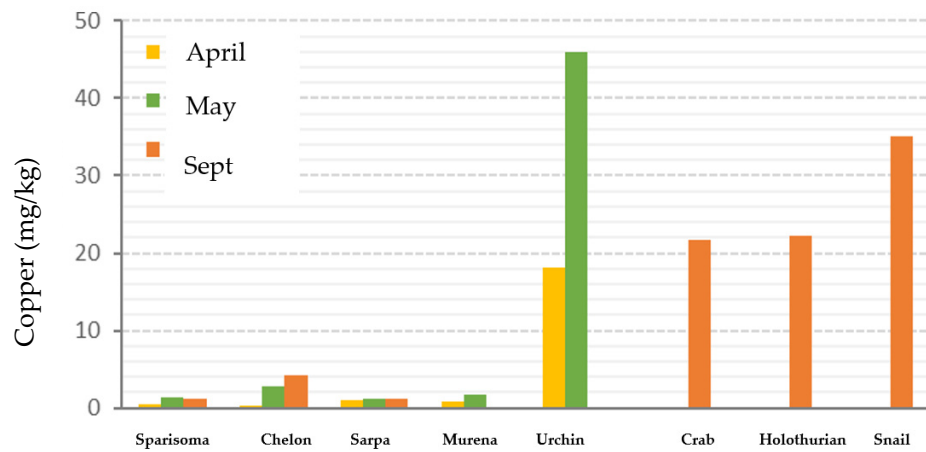
Figure 42. Copper concentration in tissues of organisms captured in the April, May and September 2018 campaigns.

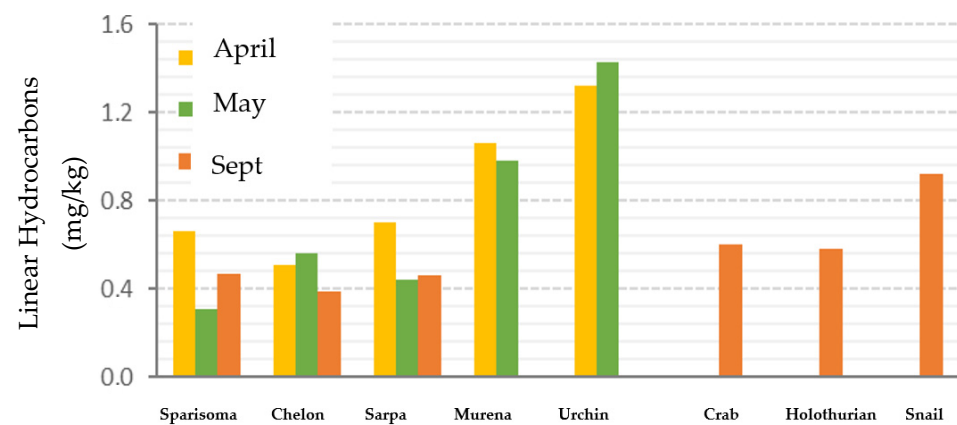
Figure 43. Concentration of linear hydrocarbons in tissues of organisms captured in the April, May and September 2018 surveys.

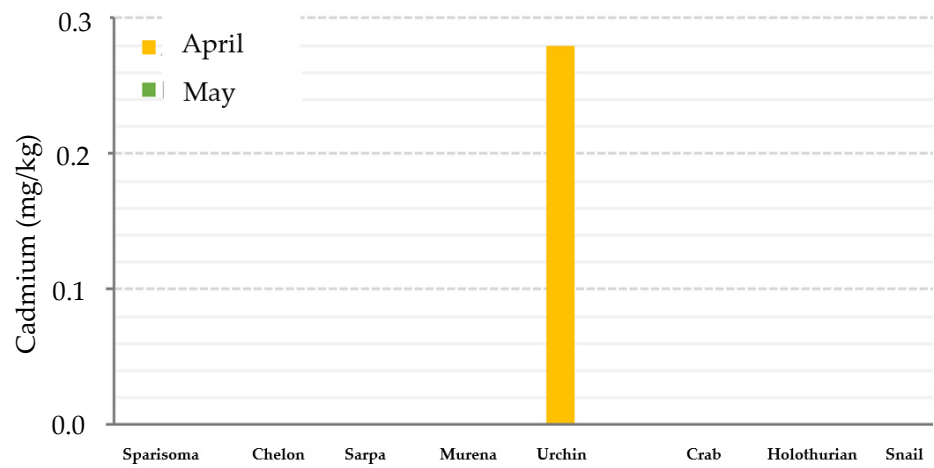
Figure 44. Cadmium concentration in tissues of organisms captured in the April and May 2018 cruises. Notice that in May cruise the concentrations are below the limits of detection.

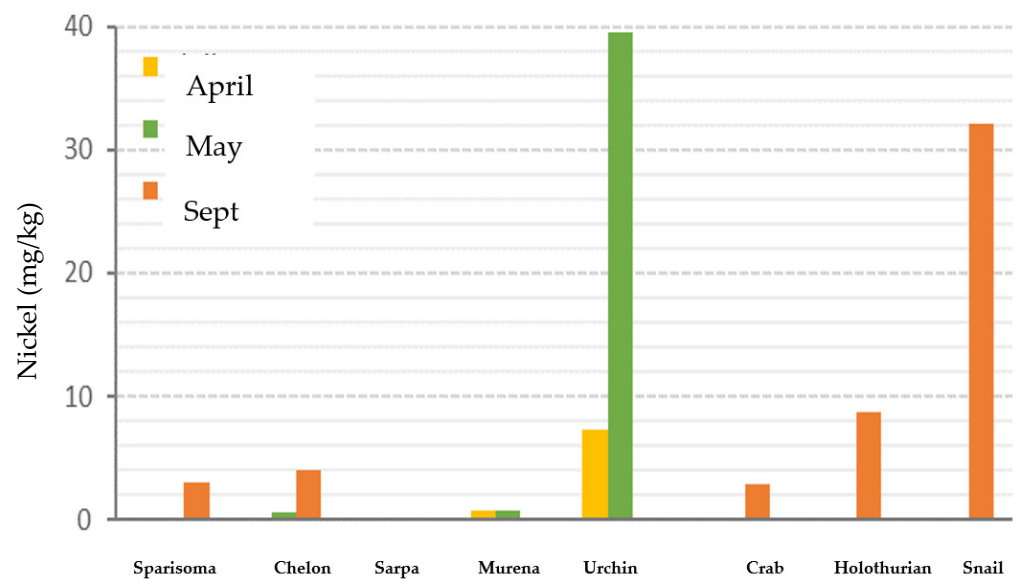
Figure 46. Nickel concentration in tissues of organisms captured in the April, May and September 2018 surveys.
