Structural Deterioration and Failure of the Laminated Wooden Roof of a Covered Swimming Pool

Abstract: A swimming pool in Corrales de Buelna (Cantabria) was demolished in March 2017 due to the loss of mechanical performance of the laminated timber structure. The relevant deterioration was caused by rotting of the wood and corrosion of the metal connecting elements. The structure featured a barrel vault with five large tri-articulated arches enclosed on the sides by inclined facades formed by toral rafters and purlins. The corresponding diagnostic process involved data collection and structural assessments to verify the structure's bearing capacity and serviceability. Data collection was carried out in December 2015 and consisted of a thermal camera inspection to determine the points of moisture accumulation and sampling openings, conduct environmental and wood hygrothermal measurements, and measure cross-sectional losses and deformations of the structural elements. Verification of the load-bearing capacity was carried out using matrix calculation structure software for both the original and deteriorated structure. The diagnosis indicated that the damage was caused by leaks in the

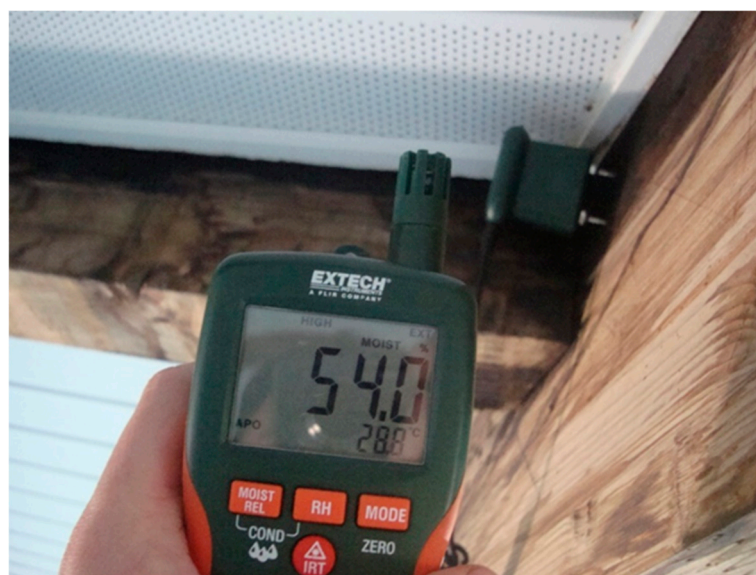
Figure 4. Measurement of wood temperature and moisture content with a needle thermohygrometer.

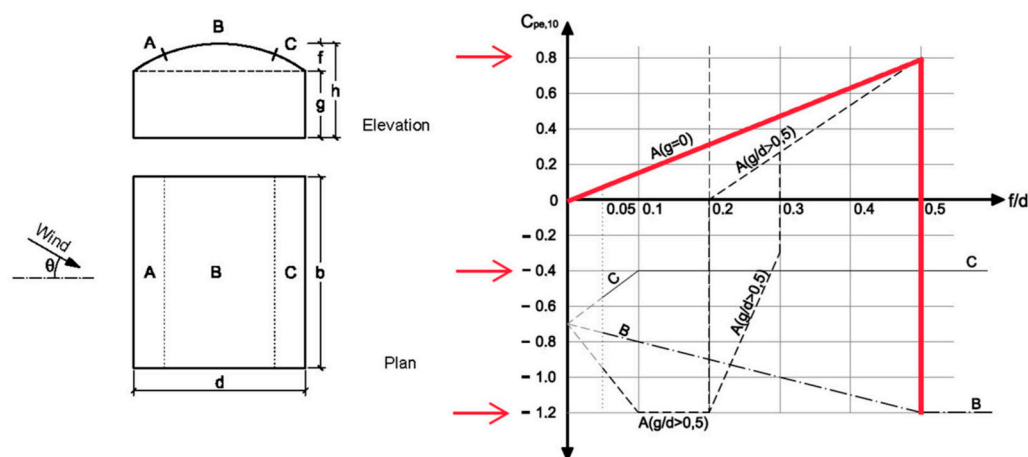
where q_b represents dynamic wind pressure (Spain, 0.5 kN/m²), c_e is the exposure coefficient according to the roughness of the surroundings (flat rural land without significant obstacles or trees, with a height of 12 m, 2.8), and c_p is the pressure or suction wind coefficient according to the shape and orientation of the building. The values of c_p were obtained from the graph in Figure 5, with a pressure wind coefficient of 0.8 in zone A and suction coefficients of -1.2 in zone B and -0.4 in zone C.

Figure 5. Pressure or suction wind coefficients on a cylindrical roof (CTE DB SE AE) [21].

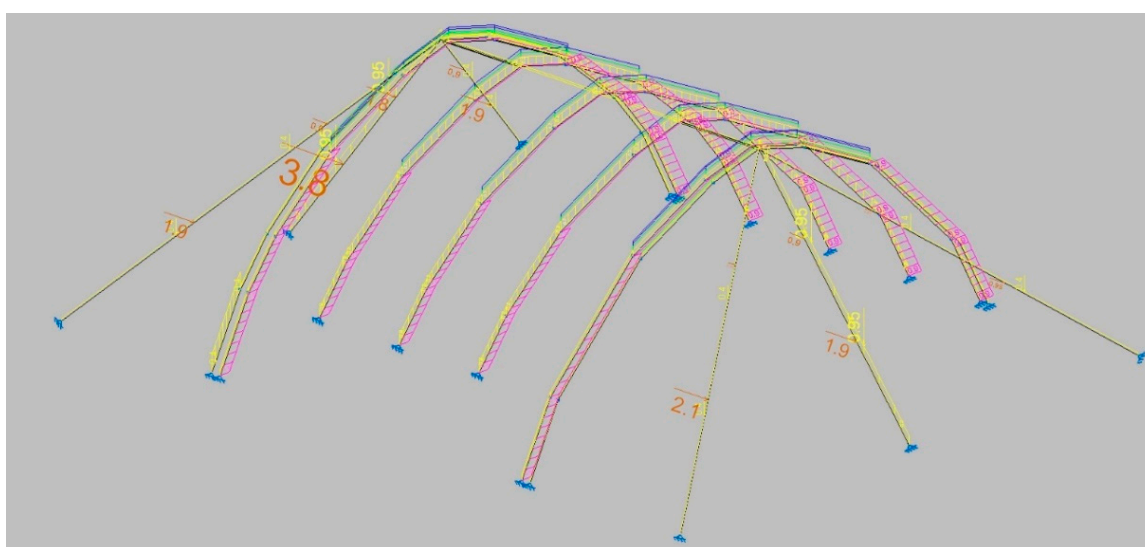
Figure 13. Loads (yellow: permanent; magenta: longitudinal wind; orange: transversal wind; green: maintenance; blue: snow).

It can be seen that the arches were already slightly undersized in the original structure, as they were stressed to more than 100% of their mechanical capacity, both in normal and fire situations (considering 60 min of fire duration). In addition, the arch keystone drop was 157 mm, which is more than allowed by the standard, of 97 mm (arch span/300). Finally, the arches of the damaged structure still did not meet the strength requirements. Therefore, the results revealed non-compliance with current regulations, requiring more overall strength and stiffness in the structure.

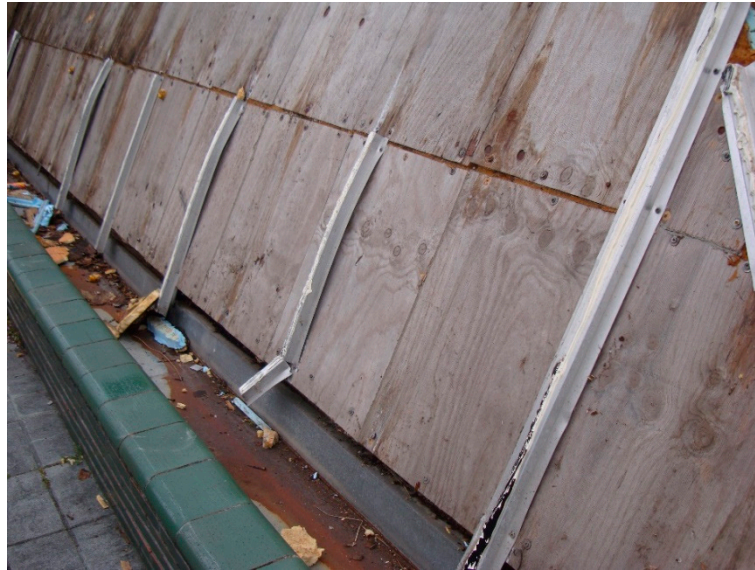
The roof was constructed using aluminum composite panels with a polyethylene core. A substructure of vertically fixed extruded aluminum omega profiles was placed on top of the wooden sandwich panel board, which was then fastened with screws to the wooden board (Figure 14). The aluminum composite panels were glued to this substructure with a polyurethane adhesive.

Figure 14. Aluminum omega profiles screwed to the wooden sandwich panel. Image taken during the demolition process.
