Detailed studies and stabilization methods of volcanic rocky slopes in coastal areas, Canary Islands, Spain

Chapter · May 2010

A. Lomoschitz & A. Cilleros

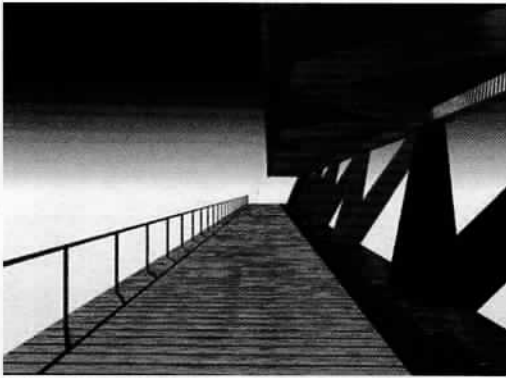
Figure 7. Designed footpath structure.

It was done a geological and geomechanical description of every material, which included an evaluation of the bearing capacity at each support point of the structure (Fig. 7).
