## RECONDITIONING OF COMPRESSION MOULDS BY LASER CLADDING

**Abstract:** This research addresses to the reconditioning of a compression mould used in automotive industry for manufacturing of rubber seals. The reconditioning process have been carried out using an CW Coherent diode laser with a maxim in power of 1000 W and a cladding head made by PRECITEC, manipulated by means of an CLOOS robotic arm synchronised with a rotational table. The NiCrBSiFeC powder (commercialised as Oerlikon Metco 15E) was used as filler material for repairing the MOULD STEEL 1.2738. Crack free and dense coatings were obtained with similar hardens and wear resistance of the base material. The samples were analysed by optical and electron microscopy and by EDS micro chemical analyses.

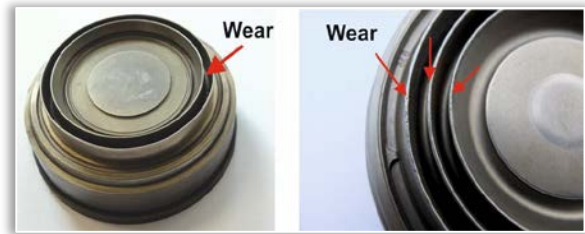
Figure 1. Examples of compression mould with signs of wear

Moulds and dies used in the automotive industry are subjected to premature wear due to the repeated moulding cycle time, heating-cooling and ejecting the piece. Fatigue, thermal shocks, corrosion and abrasion are several sources that can damage the moulds. Even mistakes in manipulation, overheating or using of tools to remove sticky parts can be sources of major damage of moulds. Figure 1 exemplifies two compression moulds with medium signs of wear on the active edge.

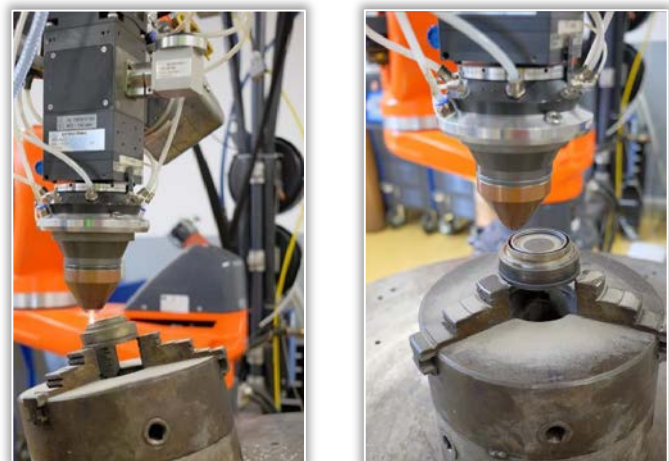
Figure 2. Compression mould during the reconditioning process

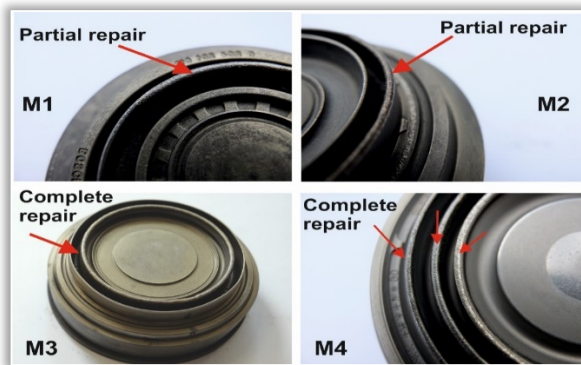
Figure 3. Compression mould after the reconditioning process

In the figure 3 is presented the appearance of different compression moulds (male and female side) after the laser cladding reconditioning process. In the case of M1 and M2 moulds only a partial repair of the active edge was necessary and moulds M3 and M4 were reconditioned on the entire ring edge. The cross-section profile of the reconditioned edge of moulds M1 and M2 are presented in figure 4. For better understanding of the reconditioning process, the M4 mould will be further analysed and discussed in this study. One single track has been laser cladded on each ring edge of M4 mould and as it can be seen in figure 5, the coated material is uniform without visible defects or unmelted powder particles. Cladding speed of 20, 22 and 24 cm/min was chosen in order to not overheat the ring edges but in the same time to obtain a good adhesion with the substrate.

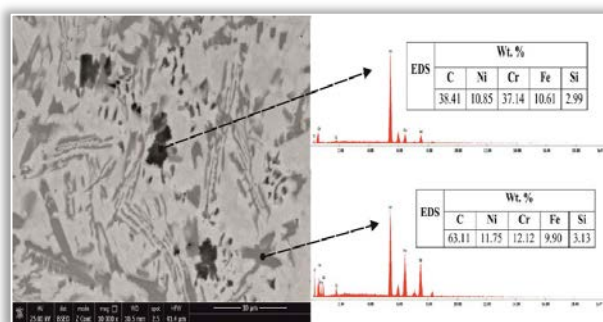
Figure 7. EDS analyses of different phases identified on the clad cross-section (ring edge R2)

The EDS micro chemical analysis indicates the presence of hard phases distributed in the nickel-iron matrix. The high amount of iron is resulted by the mixing and diffusion phenomena with the substrate. In the figure 7, it can be seen several darker areas that indicates, according with the EDS results, the presence of phases rich in C and Cr, chromium carbides that are embedded in the Ni-Fe matrix. The presence of hard phases ensures the hardness and wear resistance of the coating.

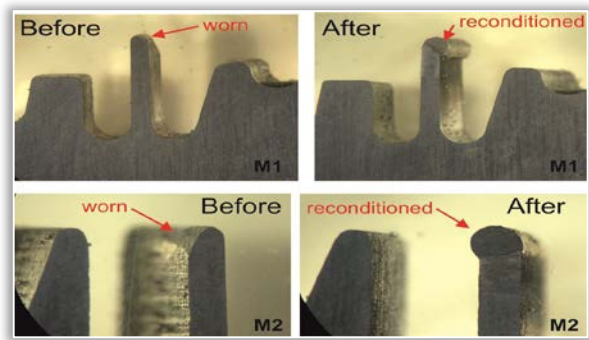
Figure 4. Cross section of moulds M1 and M2, Before and After the reconditioning process

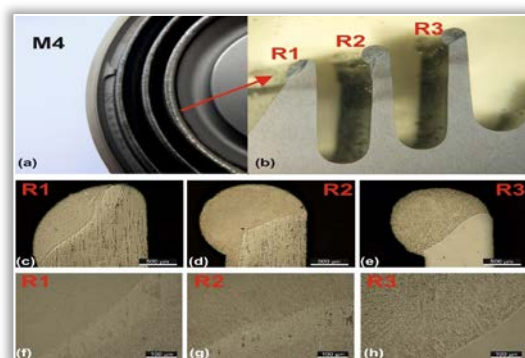
Each ring edge has been repaired with adapted speed in accordance with the ring shape geometry and depth of the worn marks. Figure 5 shows at different magnifications the cross-section profile of the three edges, R1, R2 and R3, which have been repaired. The cladded layer is free of cracks and present a good bonding with the mould substrate. The coating is dense and present a typical Ni based superalloy microstructure composed of columnar dendrite with the growth direction perpendicular on the base material. Only in the case of R3 edge, a well-defined non-interference line (planar growth) between the two materials is visible. This edge was repaired using a lower speed therefore a higher temperature and thermal gradient was created during the laser processing producing the planar growth at the bottom of the melted pool (fig. 5 h).

Figure 5. Cross section of the reconditioned ring edge of mould M4

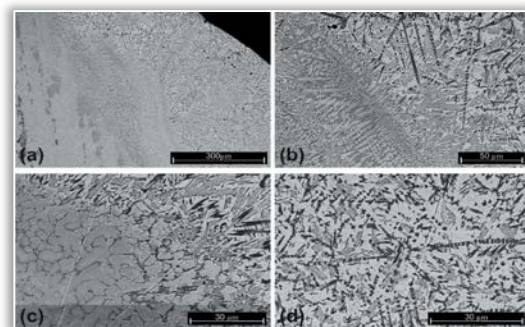
The SEM analyses of the ring edge R2 is presented in the figure 6. The details show the diffusion zone characterised by the pronounced dendrite formation with pyramidal growth in the direction of the thermal gradient. The dendrite formations are smaller and uniform distributed in the Ni matrix on the upper part of the coating where the distance from the interface with the substrate increase.

Figure 6. SEM micrographs of the reconditioned ring edge R2 from figure 3

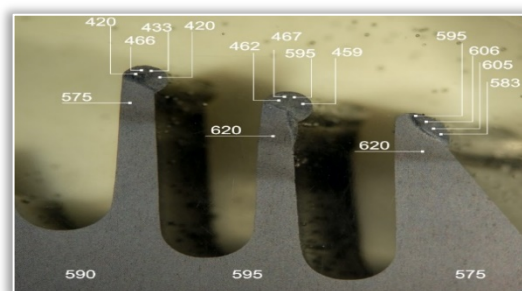
Figure 8. Results of the microhardness testing of the mould M4. Indicated values are Vickers microhardness tests results at 200 g load: HV02

The hardness of the cladded layers is influenced by the microstructure, grain size and dilution with the substrate. Figure 8 show the microhardness values measured on the coating, heat affected zone and base material of the mould 4 (M4). The highest hardness (~ 600 HV02) is registered on the R1 ring mainly due to the low dilution with the material. The obtained hardness is in accordance with the technical specification of the Metco 15E alloy deposited by laser cladding. In the case of R2 and R3 cladded area, the microhardness is with almost 150 units lower mainly due to the diffused iron from the substrate. The heat affected zone is hardened and have 620 HV02 compared with the base material characterises by a microhardness of 575-590 HV02.
